Manhole Inspection Summary

Manhole # S13GG_011MH

Insp Date: **11/8/07 10:06 AM**

Location Address: **2745 BAKER ST** Cross Street: **DUKELAND ST**

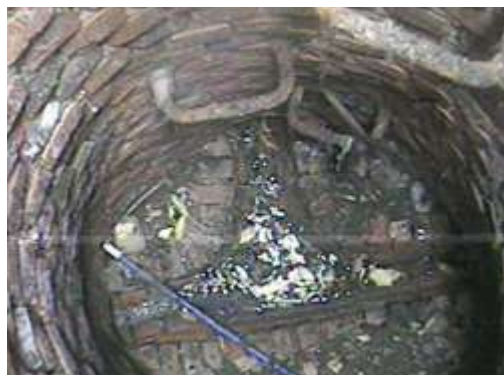
Top View

Cover Shape: **Circular** Diameter: **25.** (in.) Length: (in.) Dist A/B Grade: **0** (in.)
75

Type: **Sanitary** Condition: **Sound** Cover Material: **Cast Iron**

Frame Offset: **2** (in.) Condition: ☒ Sound ☐ Cracked ☐ Leaks

Chimney / Frame Adjustment ☒ Exists Material: **Brick** ☐ Parged Height: **0** (in.)

Condition: ☒ Sound ☐ Cracked ☐ Root Intrusion ☐ Loose Brick ☐ Deteriorated

Barrel Material: **Brick** ☐ Parged

Bench ☒ Exists Material: **Brick** ☐ Parged

Condition: ☒ Sound ☐ Cracked ☐ Root Intrusion ☐ Deteriorated ☐ Leaks ☐ Debris

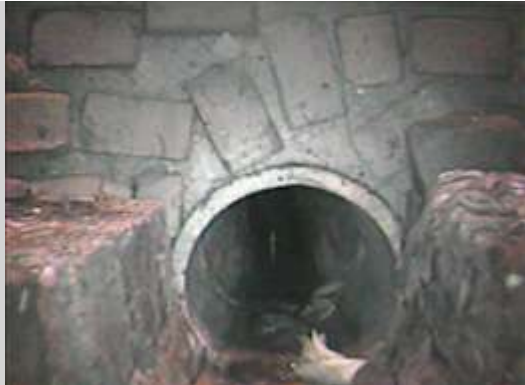
12 O'Clock Outflow

8 in. Circular Gravity Sewer
Pipe Out @ 12 O'Clock

Pipe Height: (in.) Direct
Pipe Material: **Clay** ☐ Pipe Lined
Invert Depth: **10.25** (ft.) Flow Characteristics: **Slow**
Deposits: ☒ None ☐ Mud ☐ Sludge ☐ Debris ☐ Grease
Silt Depth: (in.) Deposits Extent:
Infiltration: **None** Pipe Seal Cond: **Sound**

Drop: **None**

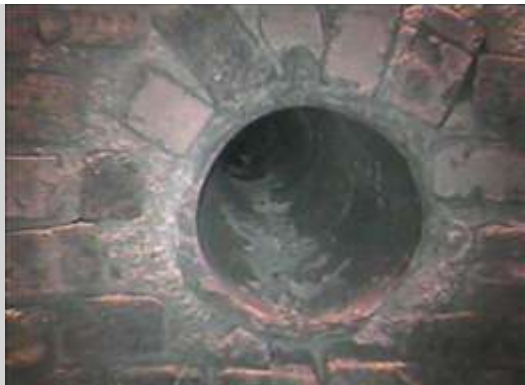
3 O'Clock Inflow

8 in. Circular Gravity Sewer
Pipe In @ 3 O'Clock

Drop In @ 3 O'Clock

Pipe Height: (in.) Direct
Pipe Material: **Clay** ☐ Pipe Lined
Invert Depth: **7.26** (ft.) Flow Characteristics: **Slow**
Deposits: ☒ None ☐ Mud ☐ Sludge ☐ Debris ☐ Grease
Silt Depth: (in.) Deposits Extent:
Infiltration: **None** Pipe Seal Cond: **Sound**

Drop: **Outside Direct**
Angled: Reading: (ft.)
Inv Depth: **10.10** (ft.)

Drop Condition: **Open**

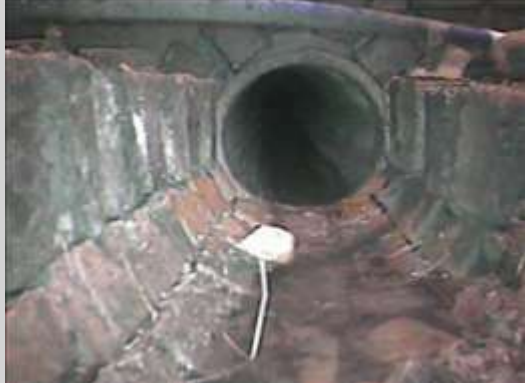
9 O'Clock Inflow

8 in. Circular Gravity Sewer

Pipe In @ 9 O'Clock

Pipe Material: **Clay** ☐ Pipe Lined

Invert Depth: **10.27** (ft.) Flow Characteristics: **Slow**

Deposits: ☒ None ☐ Mud ☐ Sludge ☐ Debris ☐ Grease

Infiltration: **None** Pipe Seal Cond: **Sound**

Drop: **None**
